edmonds center for the arts

BUILDING ENVELOPE AND SEISMIC STUDY

Edmonds Center for the Arts
Building Envelope & Seismic Study—

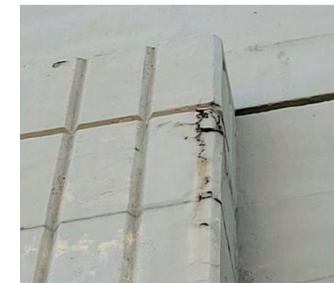
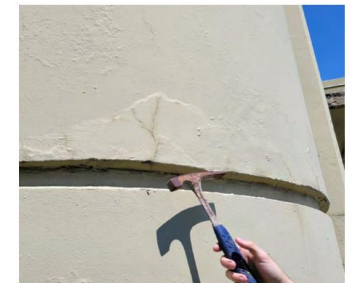
(2) 4" cores near base of wall

Remove spalled concrete

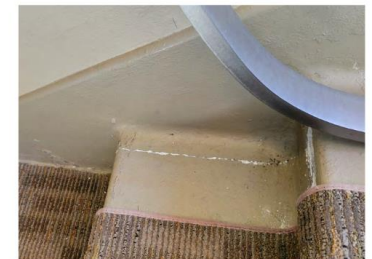
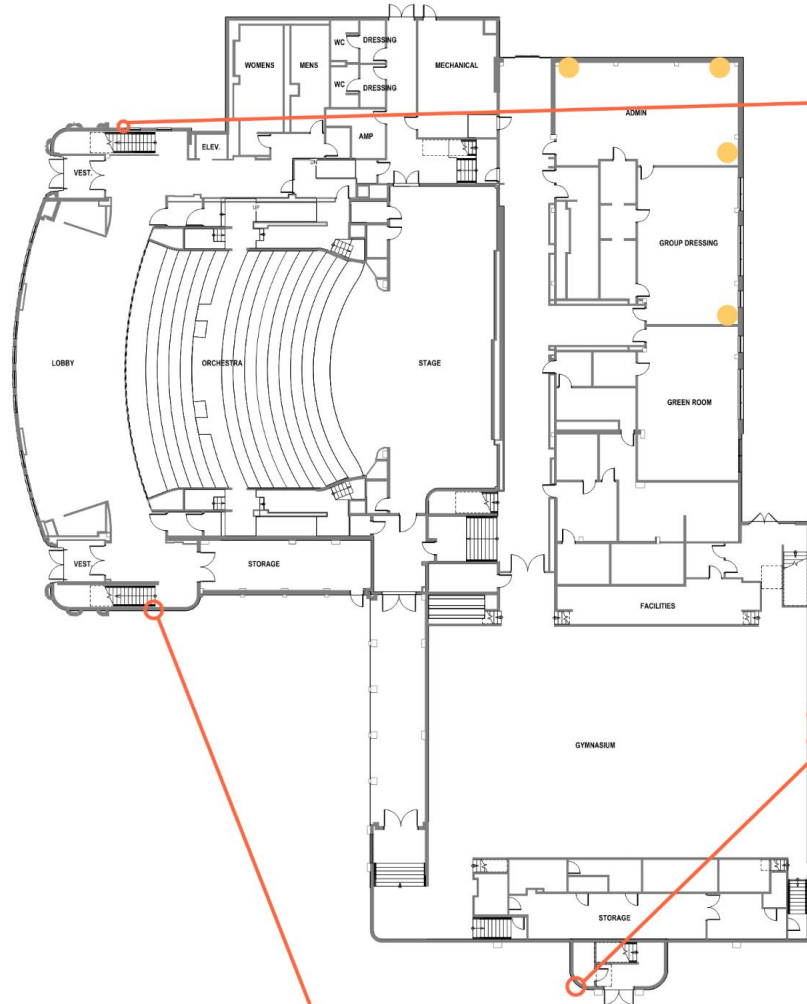
FIRST FLOOR TESTING LOCATIONS

● Hollow Clay Tile Found

Water testing

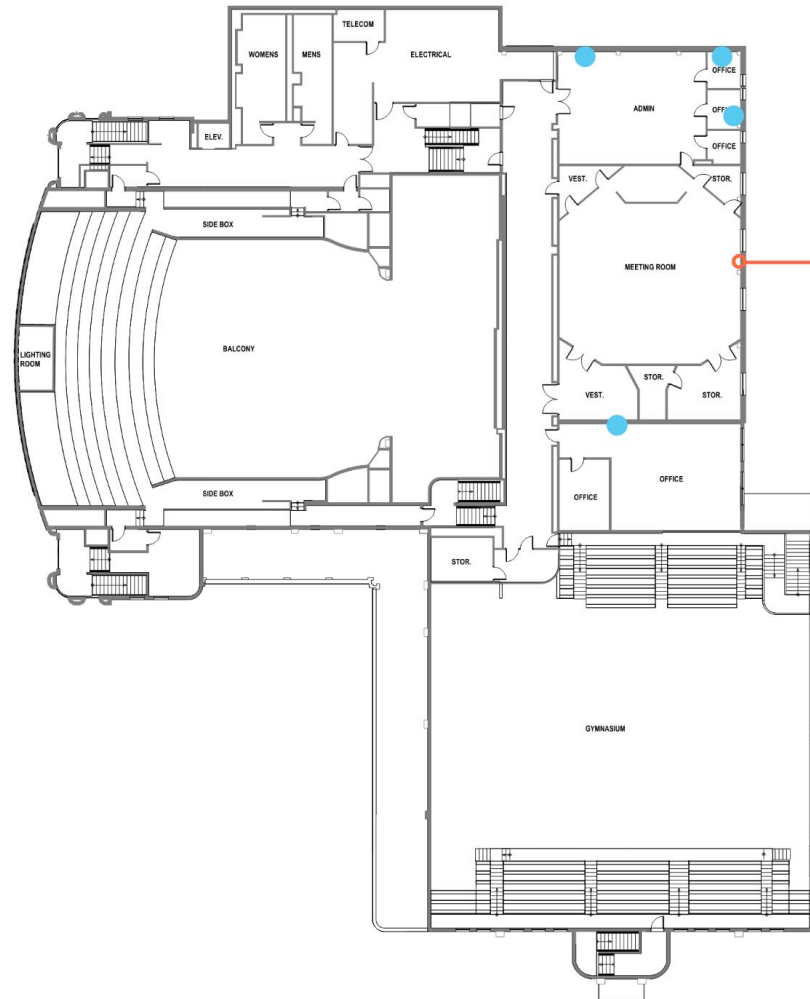
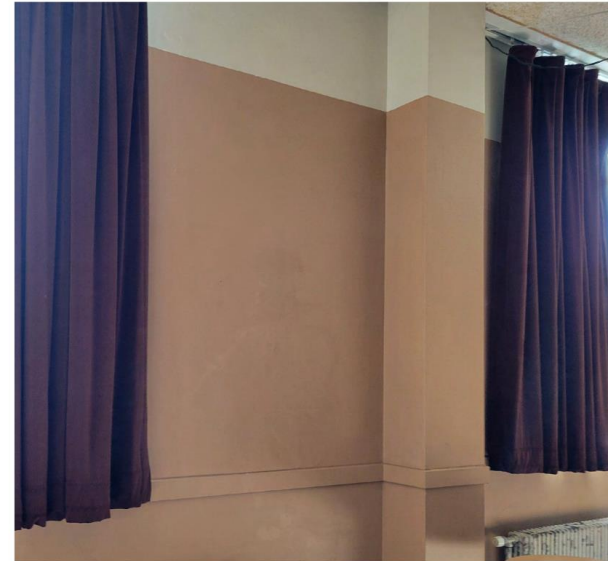
SECOND FLOOR TESTING LOCATIONS

- Masonry Testing Location

4x4 opening at interior side of exterior wall

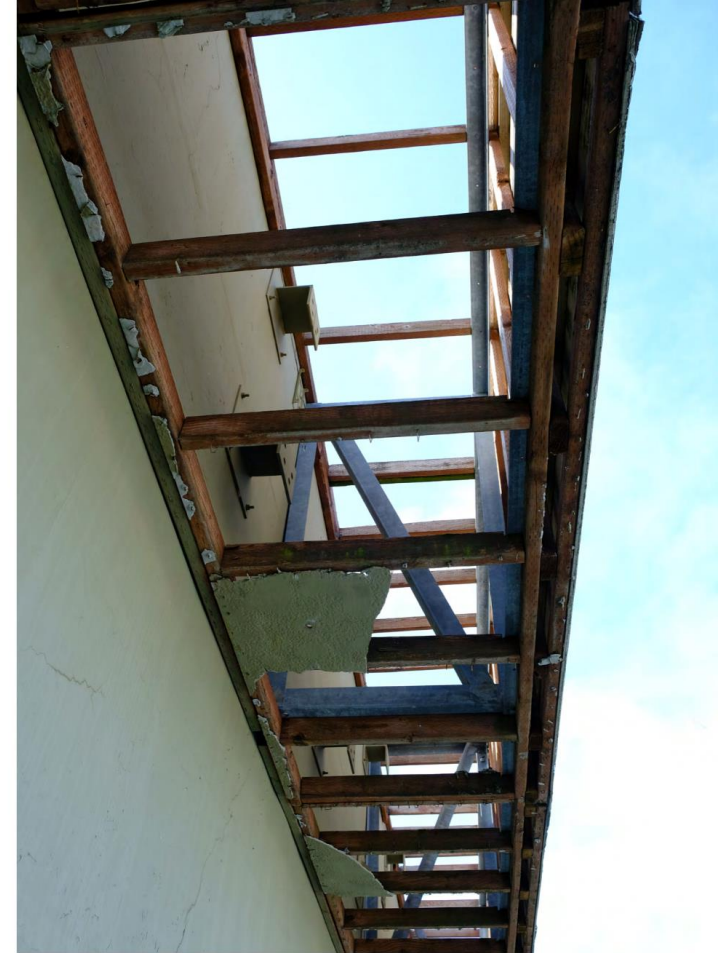
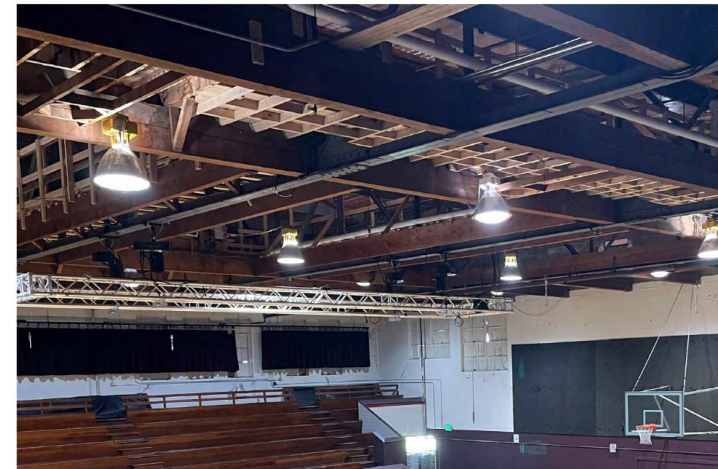
- Auditorium meets collapse prevention per 2005 requirements.
- Fly loft roof exposed wood framing is deteriorated
- Gym requires connecting roof structure to walls and improving diaphragm to meet 2023 collapse prevention requirements
- 1921 Back-of-House Building has URM and HCT walls; substantial structural intervention required to meet collapse prevention requirements

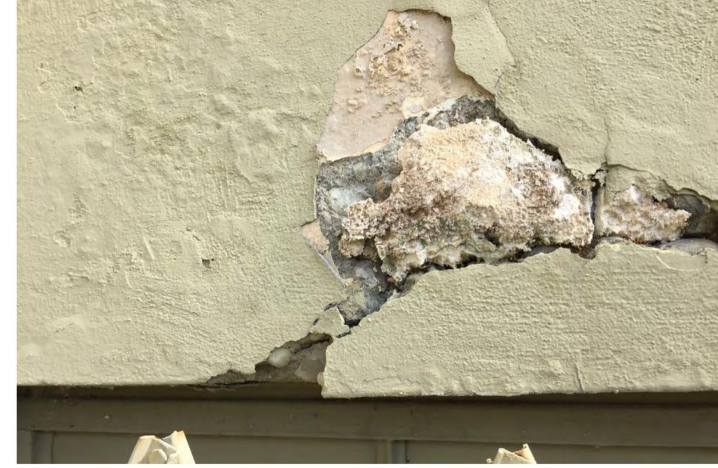
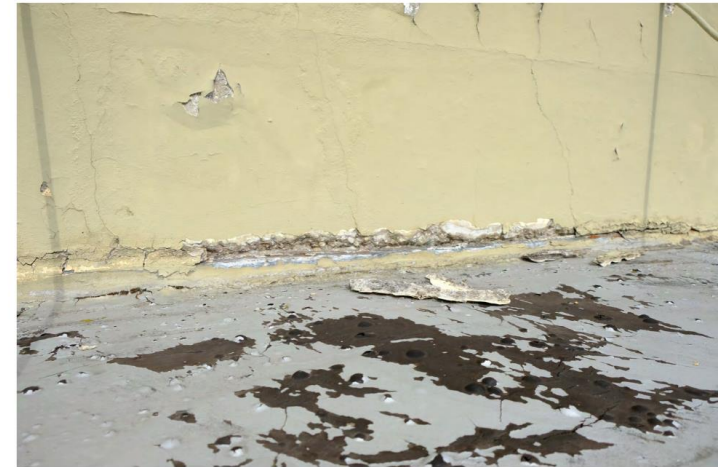
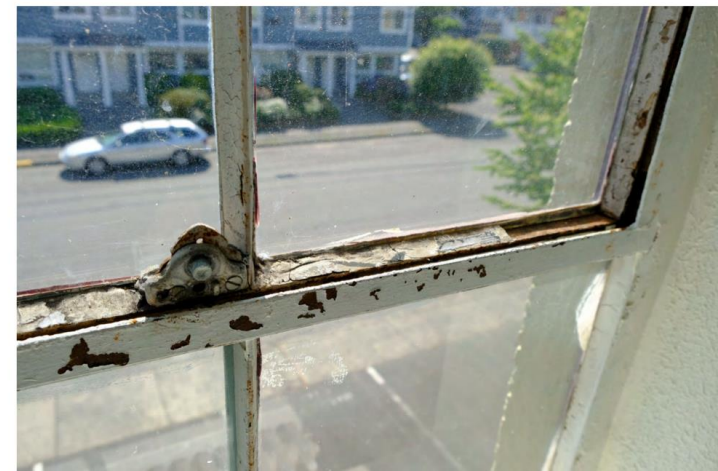
- Concrete has sporadic cracks and spalls
- Paint is not holding well at masonry; cracking and leaking present
- Windows - condensation, thermal comfort, energy loss, and frame deterioration concerns
- Older roofs are beyond service life; skylights causing heat loss
- Prior leaks have occurred in below-grade spaces

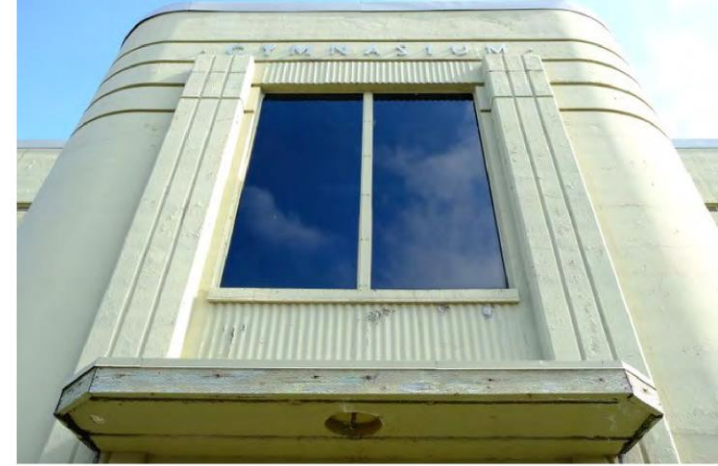
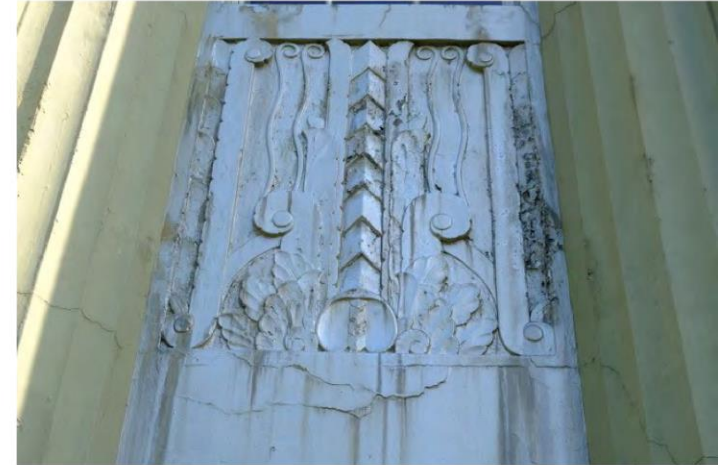
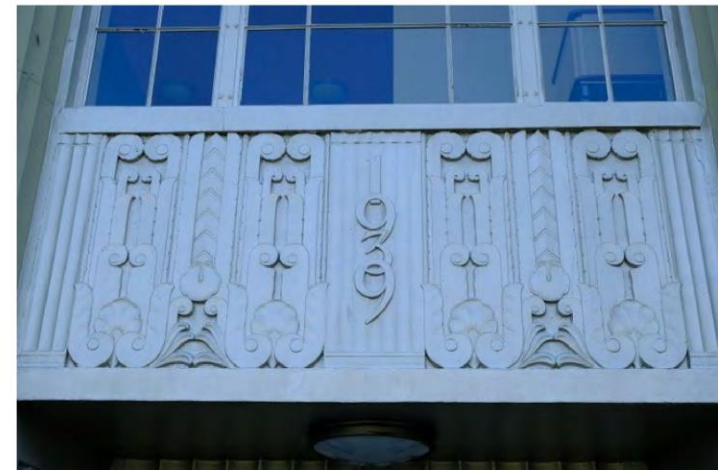
AUDITORIUM

+ HISTORIC PRESERVATION

- Not a landmark building - no restrictions
- 1939 Art Deco facade is character-defining element worth preserving

+ MINIMUM RECOMMENDED SCOPE

- Targeted concrete repair / patching
- Elastomeric anti-carbonation concrete coating
- Fly tower repair
- Roofing replacement at areas beyond useful life

+ ADDITIONAL RECOMMENDED SCOPE

- Replace windows
- Soil drainage landscape improvements

Auditorium meets collapse prevention per 2005 requirements - no seismic scope recommendations

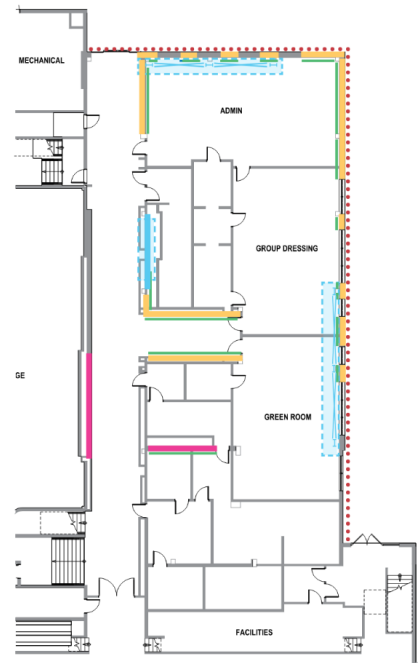
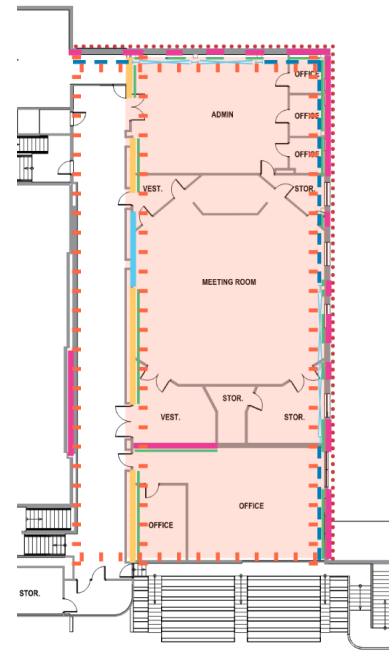
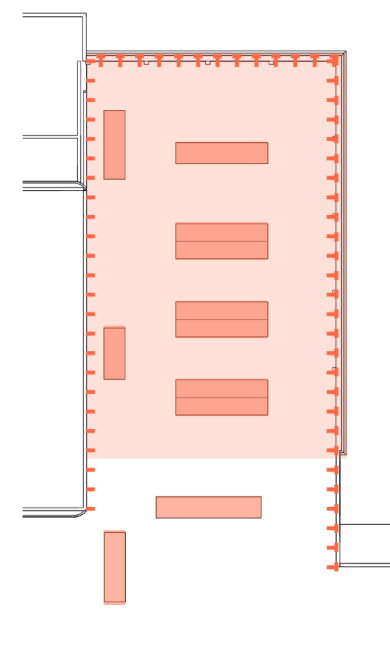
GROUND FLOOR PLAN

- (E) HCT WALL
- (E) URM WALL
- CONCRETE WALL
- BRACED FRAME
- - - FOUNDATION
- STRONGBACK
- DRAG STRUT
- REMOVE PAINT, COAT BRICK
- WALL ANCHOR
- WALL ANCHOR & CRICKET PARAPET BRACING
- RE-ROOF /DIAPHRAGM UPGRADES

- Phase 1: Roof-level structural & envelope interventions (Voluntary)
- Phase 2: Second floor level interventions - wall anchorage (Voluntary)
- Phase 3: Remaining comprehensive building renovation (Full existing building code compliance)
